Corrosion of plastic pipes – the rôle of disinfectants

Karin Jacobson, PhD Swerea KIMAB AB, Stockholm, Sweden

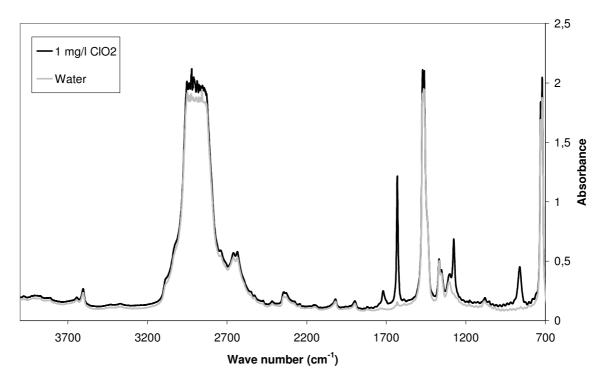
Figure 1 shows FTIR scans of a medical grade of UHMWPE (ultra high molecular weight polyethylene) which does not contain any stabiliser exposed to pure water and to water with 1 mg/l chlorine dioxide after 9 days at 50 °C. The samples have been reacted with NO-gas to mark the hydroperoxides (new peak appears at 1630 cm⁻¹) [6]. It shows that addition of chlorine dioxide changes the rate of oxidation compared to pure water. This means that chlorine dioxide on its own can initiate and/or accelerate polyethylene oxidation. This contradicts the mechanism proposed by Yu et al [2] who propose that it is a reaction product from the degradation of the stabiliser which will promote the degradation of the polymer. Colin et al [3] propose that it is only the initiation and one termination step that involves chlorine dioxide. The initiation is believed to be due to hydrogen abstraction from the polymer

Figure 1. Unstabilised UHMWPE exposed to pure water (grey) and 1 mg/l chlorine dioxide (black) for 9 days at 50 °C. Oxidation of the latter sample can clearly be seen by the peaks at 1720 cm⁻¹ (carbonyls) and 1630, 1276 and 860 cm⁻¹ (hydroperoxides after NO reaction).

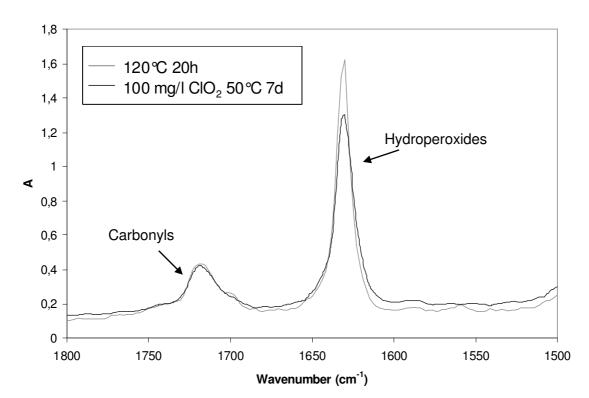
Figure 2 shows FTIR scans of one UHMWPE sample oxidised in air at 120 °C for 20 hours and one which had been exposed to 100 mg/l chlorine dioxide at 50 °C for 7 days after reaction with NO-gas to mark the hydroperoxides. As can be seen in the figure the oxidation products are about the same in the two samples.

Figure 2. Unstabilised UHMWPE exposed in air at 120 °C for 20 hours and to 100 mg/l ClO₂ for 7 days. The reaction products are almost identical (carbonyls at 1720 cm⁻¹ and hydroperoxides after NO reaction at 1630 cm⁻¹).

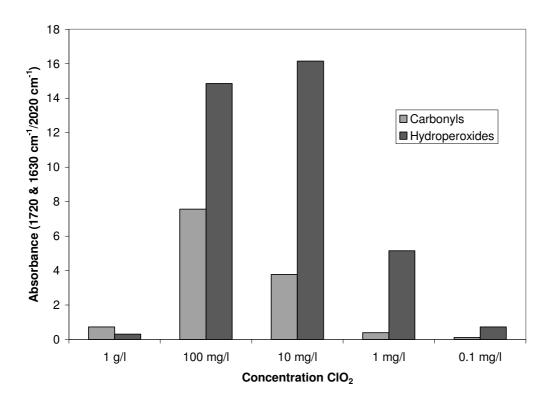
Reaction XII will thus also be a chain branching reaction just as reaction VI and VII and the peroxyl radical formed is reactive enough to abstract a hydrogen from the polymer chain according to reaction VII. Reaction XII could be the reason for the accelerated rate of oxidative degradation in chlorine dioxide. If this reaction is responsible for this increased rate of degradation the effect should be lower at high concentrations of CIO_2 . As can be seen in Figure 3 there is a very distinct drop in the accelerating effect of the oxidation of UHMWPE at 50 °C between 100 mg/l and 1 g/l chlorine dioxide which further supports this mechanism.

Figure 3. Concentration of hydroperoxides and carbonyls in UHMWPE after exposure to different concentrations of chlorine dioxide at $50 \,^{\circ}$ C for 24 hours

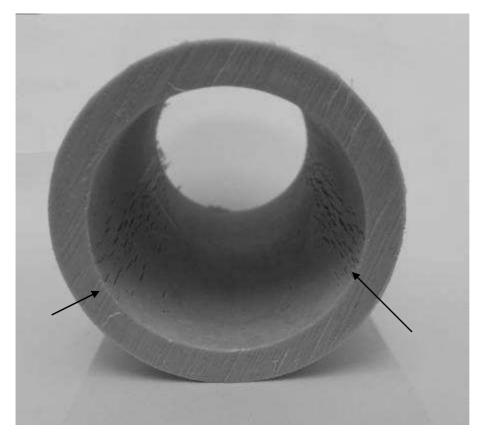
Figure 4 shows a piece of a pipe from a hot water piping in a hospital having a chlorine dioxide water purification system in order to prevent Legionella. The pipe had to be replaced due to leakage.

Figure 4. A piece of pipe from a hot water supply in a hospital using chlorine dioxide disinfection. The arrows are pointing to two bands of small cracks running in the direction of the pipe.

As can be seen in the figure there are two bands of small cracks running in the direction of the pipe. Figure 5 shows a close up of the cracks.

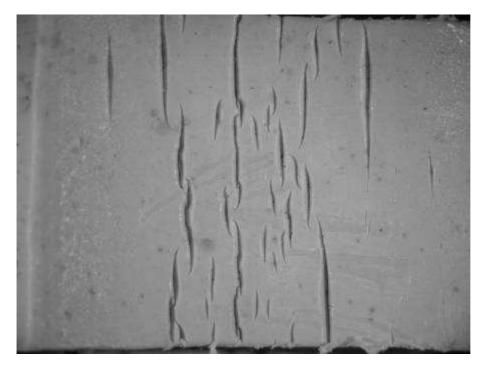
Figure 5. A close up of the surface with the cracks.

In Figure 5 it can also be seen that the inside surface of the pipe has a powdered layer that is easily scratched off.

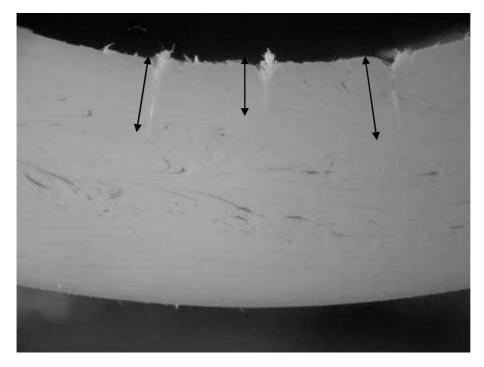
Figure 6 shows a cross section of the pipe wall. It is quite clear in this picture that the polymer in the pipe is not well mixed. It is quite possible that the mechanical properties of this pipe have been badly affected by poor processing. In addition, the cross section of some of the cracks can be seen. The cracks have here penetrated up to about 1.6 mm into the pipe wall.

Figure 6. Cross section of the pipe wall. The arrows are indicating the penetration depth of the cracks.

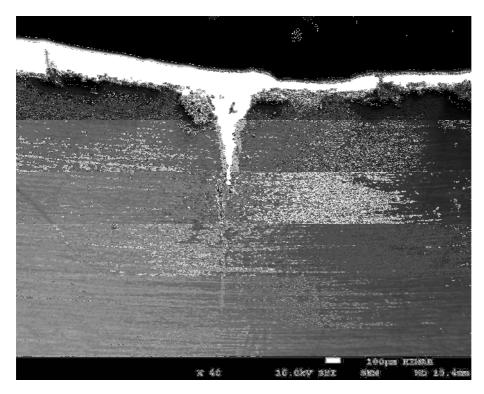
Figure 7 shows an SEM picture in 40 times enlargement of one of the cracks. As can be seen it consists of two parts. One wide crack and one thin which has propagated from the tip of the wide one.

Figure 7. SEM picture in 40 times enlargement of one of the cracks.

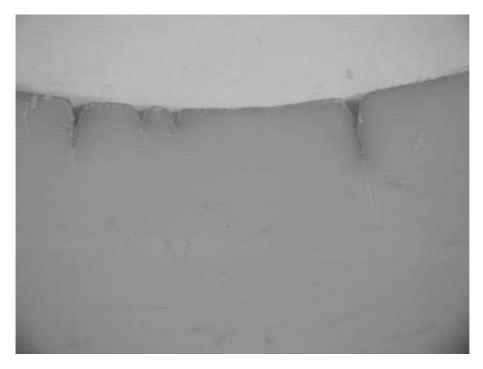
SO_2 can be used to stain polyolefins to visualise hydroperoxides (which are normally the primary oxidation product) [8]. In Figure 8 the cross section of the pipe wall after reaction with SO_2 is shown. As can be seen hydroperoxides are present but localised to the surface of the pipe wall and on the inside of the wide part of the crack.

Figure 8. The cross section of the pipe wall after reaction with SO₂ to visualise the hydroperoxides.

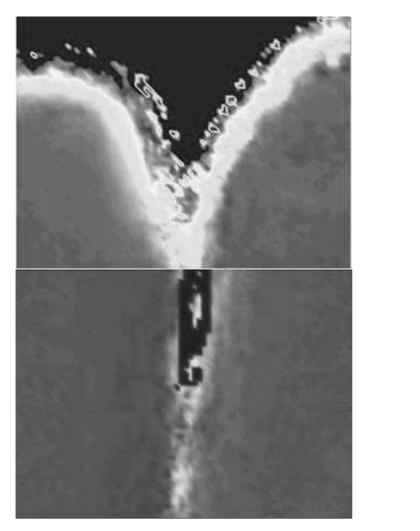
Figure 9 shows the FTIR image of the carbonyl distribution (1720 cm⁻¹/1330 cm⁻¹) of one of the cracks. As can be seen in the figure the oxidation is limited to the outermost surface and only in the wide part of the crack. The degree and depth of oxidation seems to be the same at the surface of the crack as in the wide part of the crack. The propagating crack tip does not show any signs of oxidation.

Figure 9. FTIR image of one of the cracks which have propagated

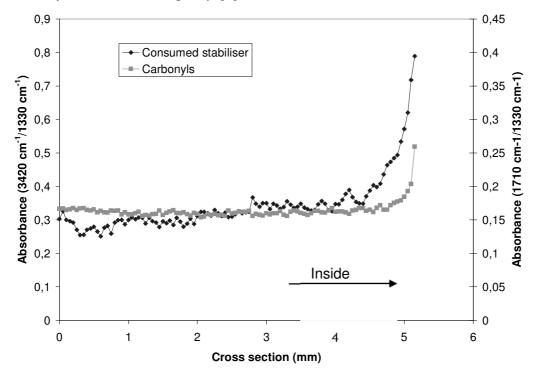
As mentioned in the introduction, chlorine dioxide easily reacts with phenols and due to this the hindered phenol stabilisers are quickly destroyed when exposed to CIO_2 . When exposing a polyolefin which contains a hindered phenol stabiliser to a water solution with chlorine dioxide there is an initial large water absorption found in the sample which can be studied with FTIR. This disappears slowly when the sample is removed from the water but it can be seen again once the sample is exposed in pure water. This phenomenon is believed to be due to water being bonded to reaction products formed by the reaction between the hindered phenol and chlorine dioxide. By treating the cross section of the polypropylene pipe wall with pure water (at 50 °C for 18 hours) a clear water absorption could be found in the part of the wall closest to the inside of the pipe, Figure 10. This indicates that the hindered phenol in this part of the pipe has been attacked by chlorine dioxide which has diffused into the pipe. As can be seen in Figure 10, which also shows the carbonyl index over the cross section, it seems as if the stabiliser is consumed just ahead of the oxidation front.

Figure 10. FTIR line scans through the cross section of the pipe wall showing the distribution of carbonyl groups and water. The water absorption is a result of reaction products from the degraded stabiliser and can thus be used as a measure of consumed stabiliser.

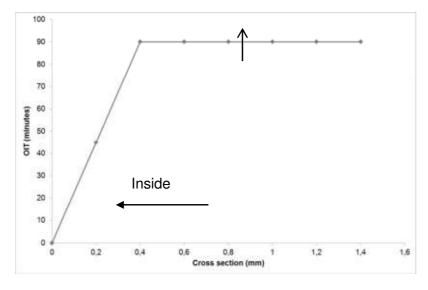
The results from OIT measurements on samples microtomed stepwise from the surface and into the bulk of the pipe are shown in Figure 11. These results indicates that the stabiliser is completely lost at the surface, slightly reduced further in but that the rest of the pipe still has a large quantity of active stabiliser.

Figure 11. OIT of samples cut from the inner surface and into the bulk of the same sample as shown in Figure 10. The OIT of all the samples except for the two closest to the surface was more than 90
